# CRASH & SAFETY ANALYSIS

**Date:** May 15, 2024

**Subject:** **Urban Middle School – Mill Road Crash & Safety Study  
City and Town of Sheboygan, Sheboygan County, WI**

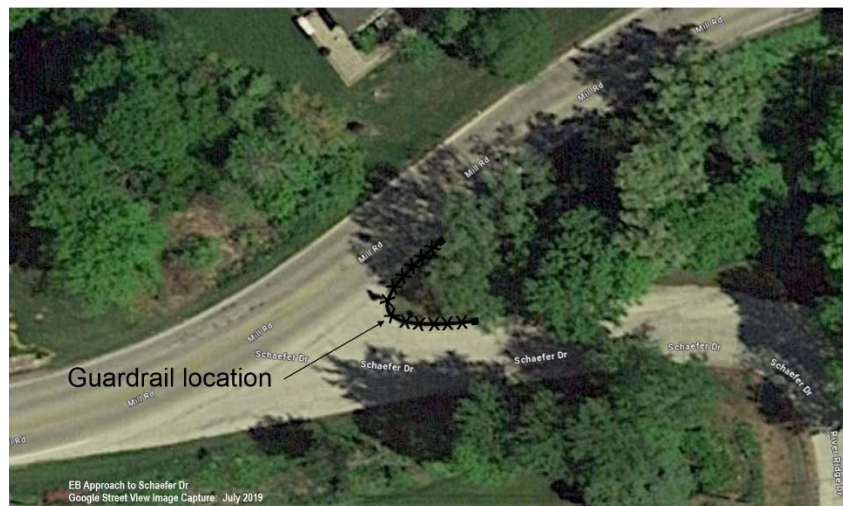
The second location with 2 crashes was on the eastbound approach to Schaefer Road which splits off from Mill Road continuing due east while Mill Road curves to the north. A ravine exists at the point of the curve, between these two roads. There are two warning signs (arrows) indicating that the driver should follow the curve to the north and an additional dead-end sign on the entrance to Schaefer Road. One of the crashes involved an eastbound vehicle on snowy

pavement, speeding while trying to negotiate the curve. The driver hit one of the arrow signs and then a tree. The crash resulted in a B-level injury. The second crash also involved an eastbound vehicle trying to negotiate the curve. For this crash, the driver managed to miss the sign while still hitting the tree. This crash was reported as occurring under icy snowy conditions, but speeding was not mentioned in the crash report. The driver was uninjured and able to exit the vehicle even though the vehicle tipped on its side. Both crashes occurred during the day under poor roadway conditions. Although there was not a pattern of crashes at this location and modifications are not typical when a pattern isn't identified, the following mitigation techniques could be considered.

2. Installing a guardrail, as shown below, could prevent vehicles from hitting the arrow signs as well as entering the ravine or overturning or striking trees. Should crashes occur, however, maintenance costs of repairing and/or replacing the guardrail should be considered when contemplating this safety enhancement.

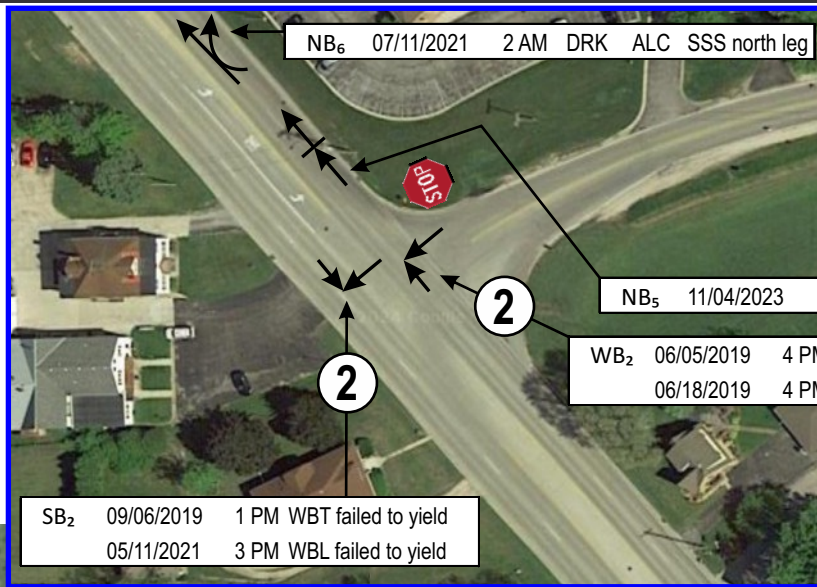
# **CRASH PLOT**

Crashes investigated at this intersection occurred between 2019 and 2023 and were located on STH 42. Crashes on the Mill Road approach to this intersection were included in the corridor crash study listed above. There were six crashes that remained after reviewing the crash reports. One crash that occurred north of the intersection outside of the intersection influence area and one crash that involved a mechanical issue were removed from the safety analysis and were not included in the statistics. The remaining six crashes included two crashes occurring north of the intersection and within the 250-foot area of influence of the intersection. The remaining four crashes were right angle crashes where the westbound vehicle failed to yield to either northbound or southbound vehicles. Three of these crashes occurred in 2019. A traffic signal, as recommended in the Urban Middle School traffic study report, could help to mitigate right-angle crashes like these in the future.

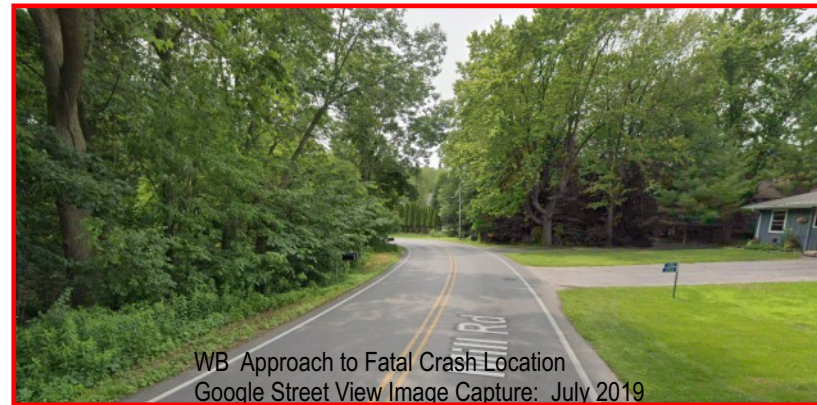
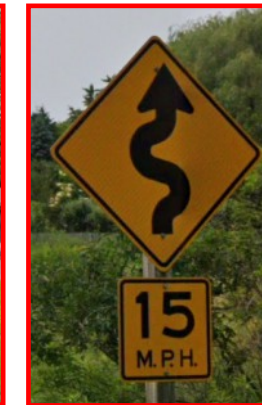
12/01/2014 10 PM **FATAL** DRK Fatal crash - ROR, ditch, tree  
This Fatal crash is not included in the statistics and occurred in 2014.
